# **PRE-CERCLIS SITE SCREENING REPORT**

Federated Metals Division Site  
St. Louis, Missouri

August 31, 2006

# MISSOURI SUPERFUND PRE-CERCLIS SITE SCREENING FORM

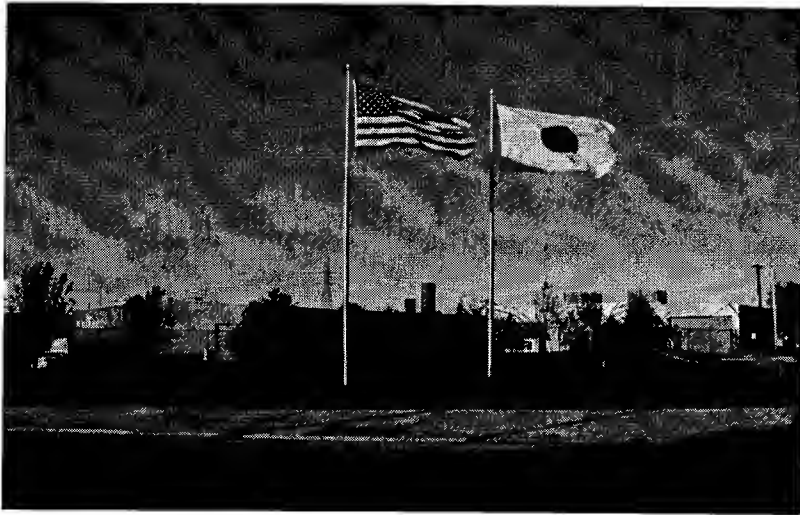
**Photograph 1**

View of neighboring property located in  
Federated Metals Division site area.  
View looking northwest.

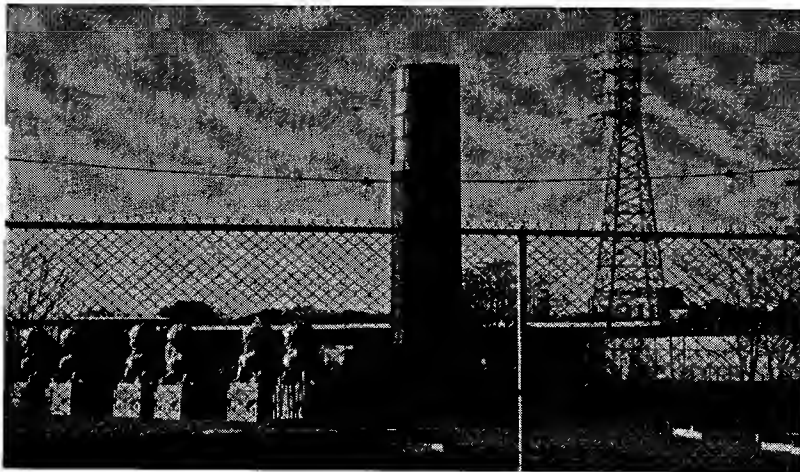
**Photograph 2**

View of a smoke stack on neighboring  
property located in Federated Metals  
Division site area. View looking west.

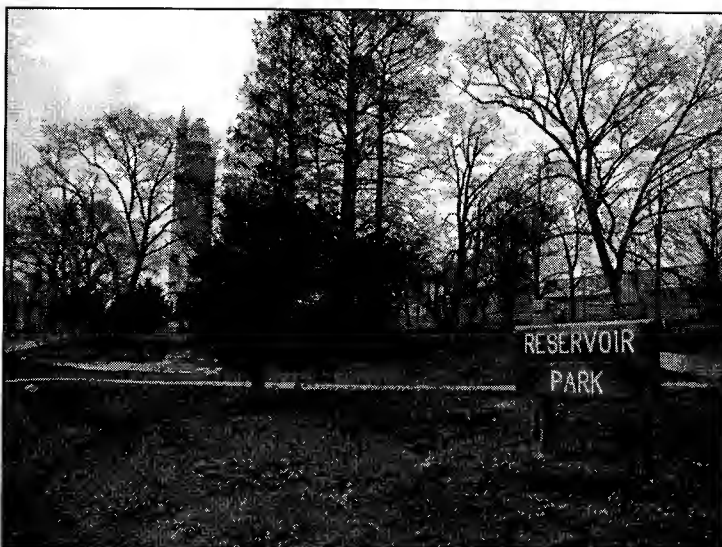
**Photograph 3**

Compton Hill Reservoir Park, view of  
sampling location 1. View facing north  
from corner of Grand Boulevard and Russell  
Boulevard.

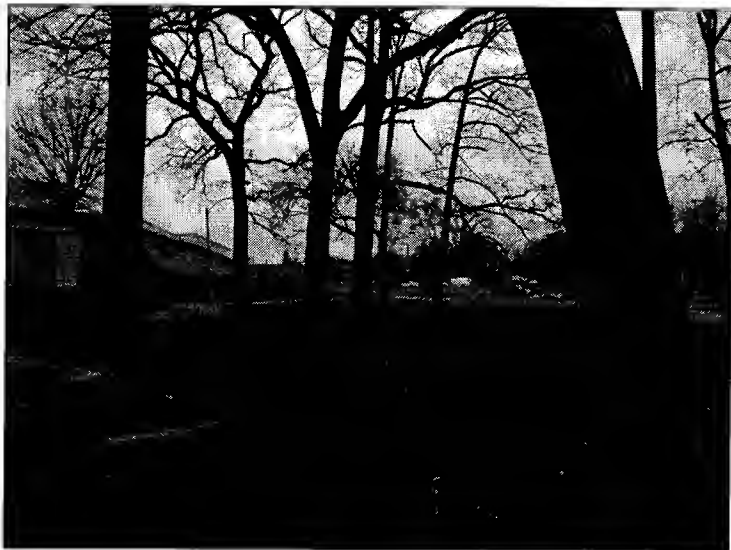
**Photograph 4**

Compton Hill Reservoir Park, view of  
sampling locations 1. View facing north from  
Compton Hill Place.

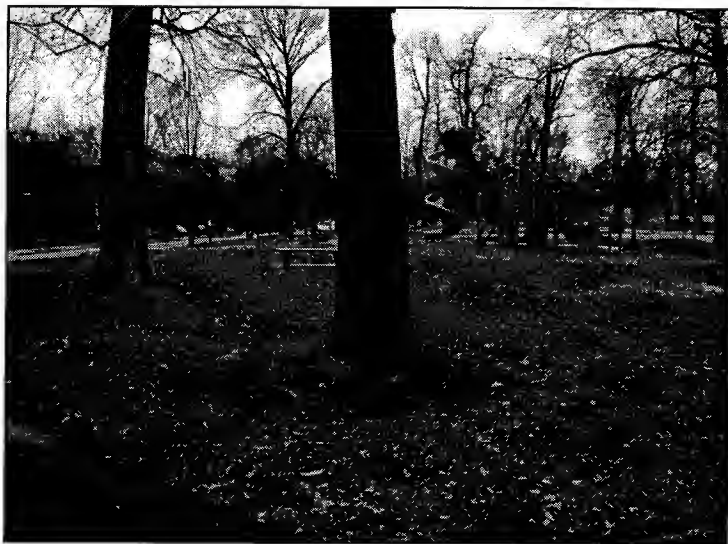
**Photograph 5**

Compton Hill Reservoir Park, view of  
sampling location 1. View facing south  
towards Compton Hill Place.

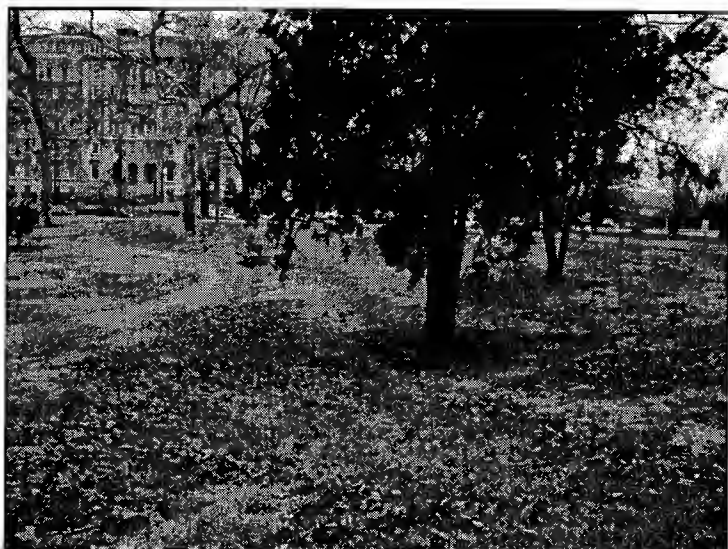
**Photograph 6**

Compton Hill Reservoir Park, view of  
sampling location 1. View facing east towards  
Grand Boulevard.

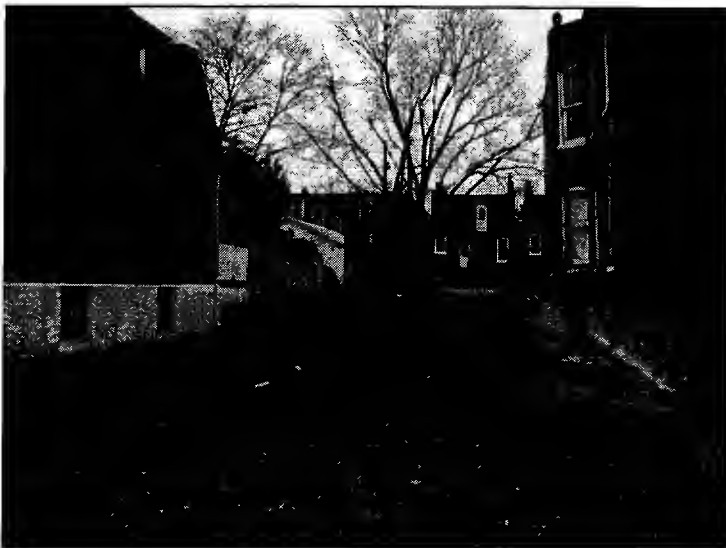
**Photograph 7**

4136 Flad Avenue, view of sampling  
location 2. View facing south from Flad  
Avenue.

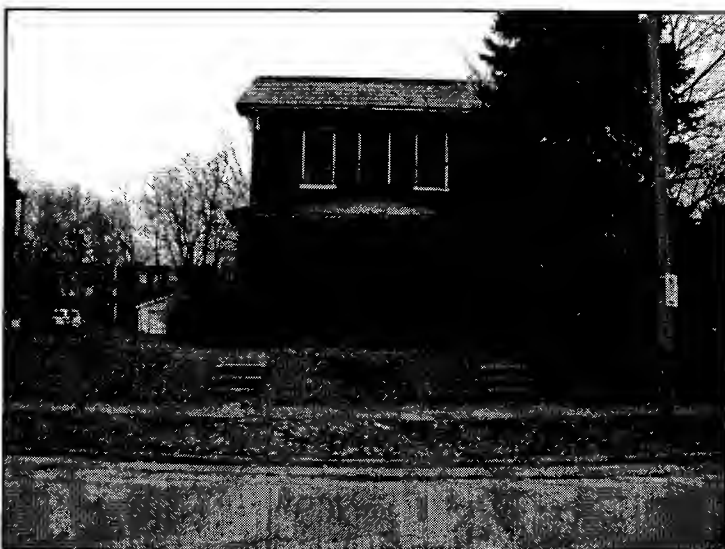
**Photograph 9**

1426 DeTonty Street, view of sampling  
location 4. View facing south from DeTonty  
Avenue.

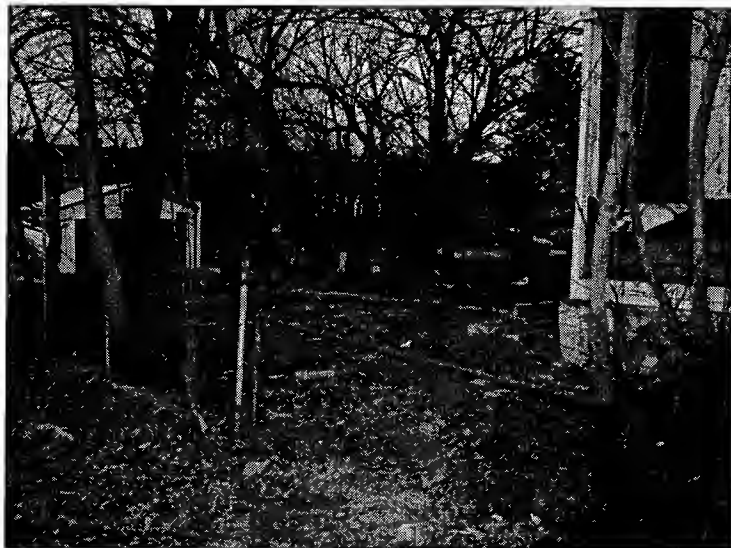
**Photograph 10**

1426 DeTonty Street, view of sampling  
location 4. View facing southwest from  
southeast corner of 1426 DeTonty Street  
residence.

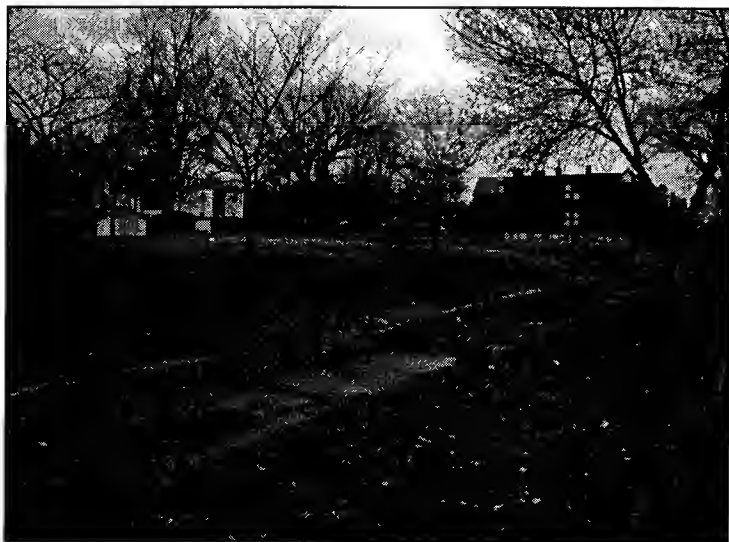
**Photograph 11**

4154-4156 DeTonty Street, view of sampling  
location 5. View facing southwest from  
DeTonty Street.

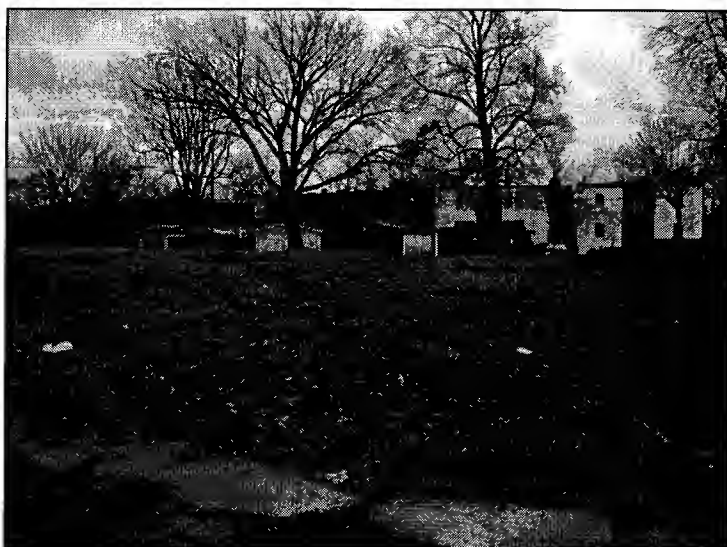
**Photograph 12**

4154-4156 DeTonty Street, view of sampling  
location 5. View facing south from  
DeTonty Street.

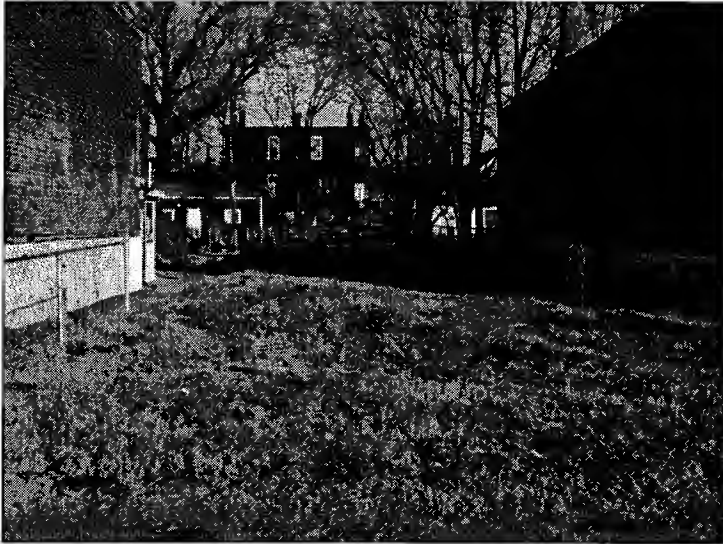
**Photograph 13**

4333 Hunt Avenue, view of sampling  
location 6. View is facing north from Hunt  
Avenue.

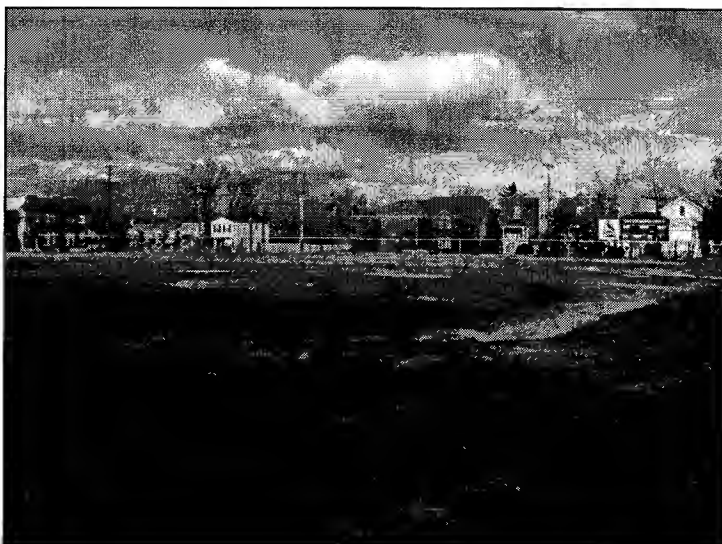
**Photograph 15**

Adams Park, view of sampling location 7.  
View is facing northwest from Vista  
Avenue.

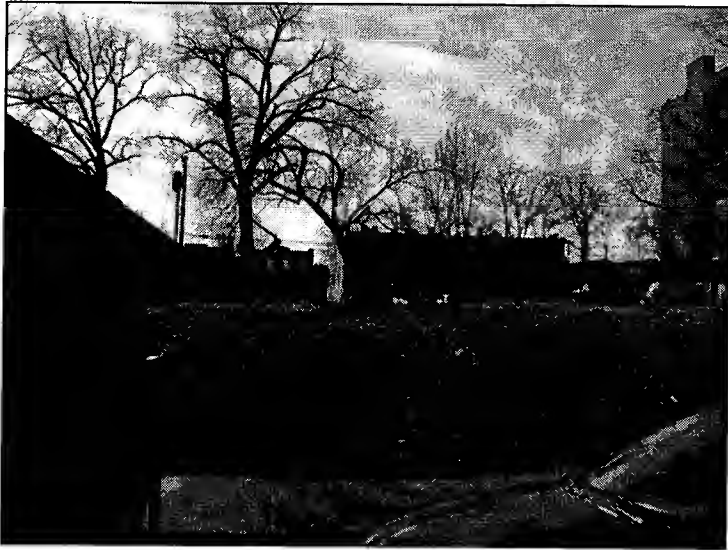
**Photograph 16**

4312 Manchester Avenue, view of sampling  
location 8. View is facing southeast from  
Manchester Avenue.

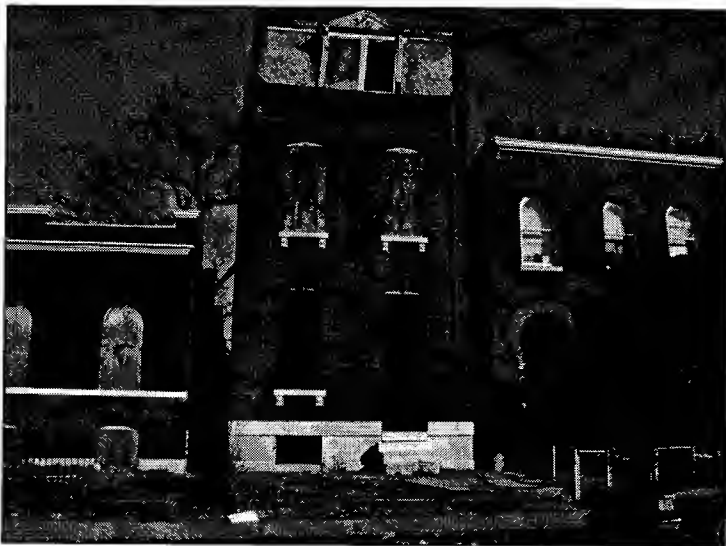
**Photograph 17**

4311 Gibson Avenue, view of sampling  
location 9. View is facing southeast from  
alley north of Gibson Avenue.

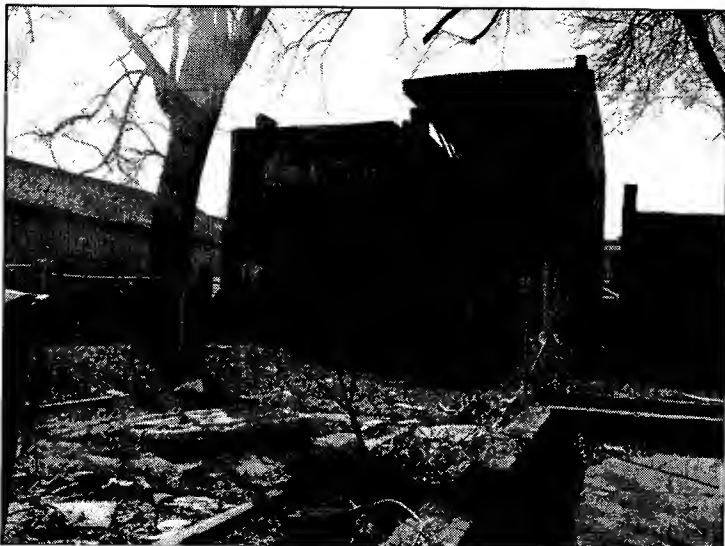
**Photograph 18**

4311 Gibson Avenue, view of sampling  
location 9. View is facing southeast from  
alley north of Gibson Avenue.
